Grafton Bridge Strengthening

Will Pank, Associate – Bridges, Beca Infrastructure Ltd

SYNOPSIS

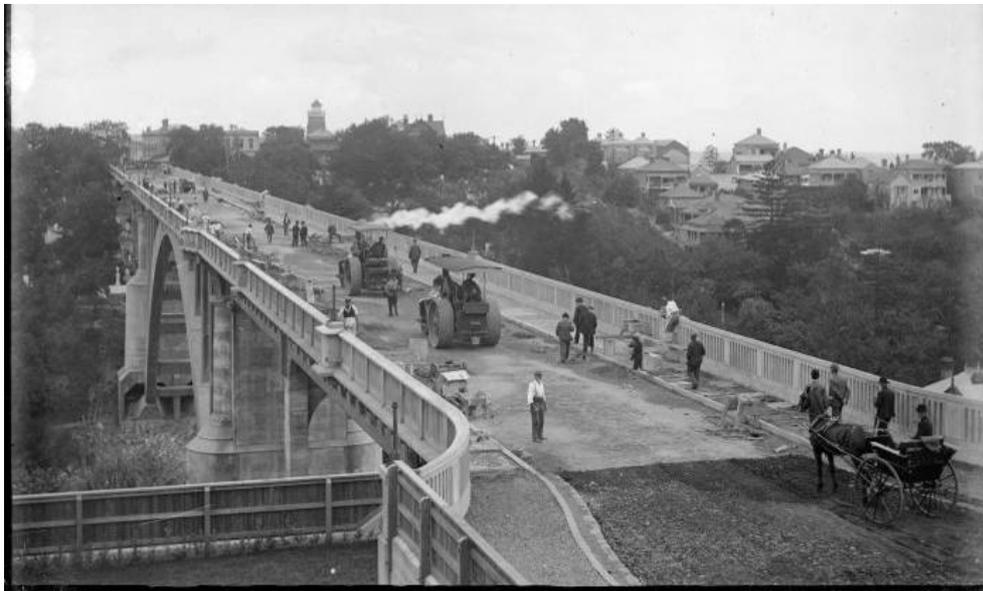
Figure 2 – Steamrollers load testing Grafton Bridge prior to opening in 1910

Designed in 1906 and built by the Ferrocement Company of Australasia, Grafton Bridge was the longest reinforced concrete span in the world when it was opened in 1910. As a pioneering example of this type of structure a great deal of attention was paid to the record-breaking 98m arch span. The design was checked by Professor Moersch in Germany, and a condition of payment for the turn-key project was that the arch had to be load tested prior to opening. Road aggregate, weighing 5kN/m^2 was placed on half the arch and deflections of 3.5mm measured. Then two 17 tonne steam rollers were moved across the bridge simultaneously proving the load-carrying capacity. The grand opening marked a huge achievement for the city. However, the contractor went bust during construction and it appears not enough attention was paid to the approach spans, since within a decade major shear failures of the 25m span vierendeel girders were seen and the first load restrictions were put in place.

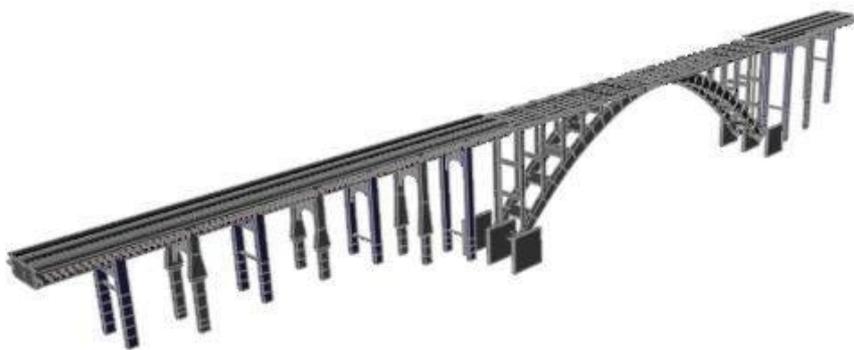
Figure 4 – 3d Structural Analysis Model

Beca carried out response spectrum analysis of 3 dimensional models of the whole bridge structure. In longitudinal and transverse modes of vibration the stiffer, shorter piers were found to attract large forces. These piers are 3 foot (0.915m) by 5 foot (1.525m) in cross section, extend up to 15 down through soft strata to founding material and are very lightly reinforced.

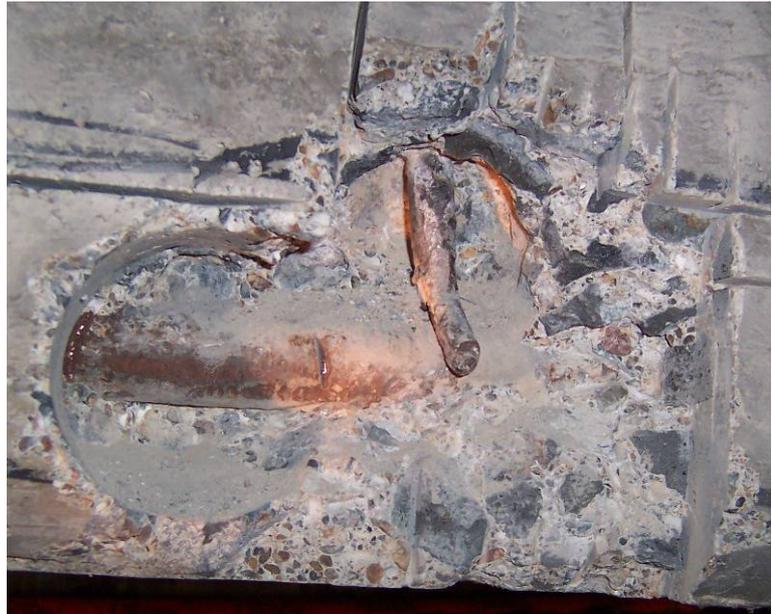
Figure 6 – Shear Bar Photo showing exposed reinforcement

The deck beams constructed in 1908 have some unusual detailing that defy a code approach to assessment and design. Reinforcement was fixed in so called “trusses” with top and bottom longitudinal bars held by vertical shear bars with split ends formed into a fish-tail detail around main bars. The spacings of these fish-tailed bars varies with a higher concentration close to supports reducing towards mid-span regions. One or two of these “trusses” are fixed in beams with additional main bars bent up over supports of continuous beams.

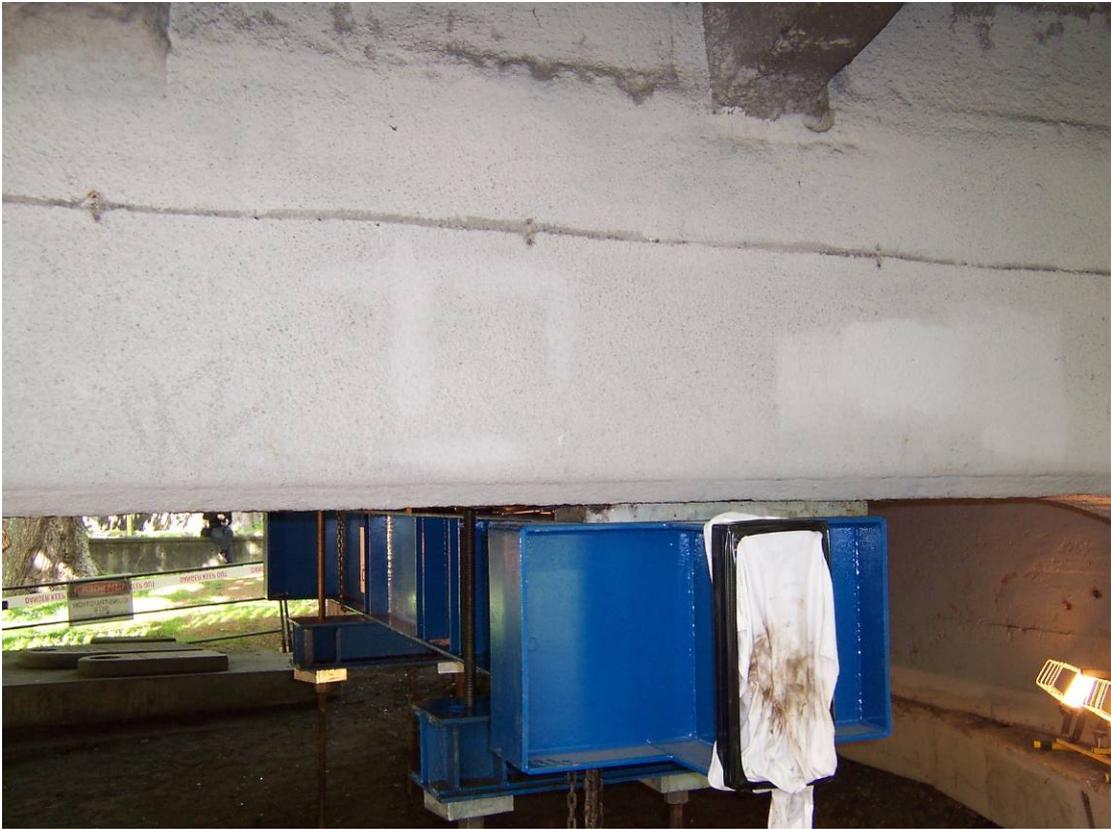
Figure 8 – Load Test Reaction Beam Below Deck

We arranged for testing of approach span transverse beams, of which there are approximately 200. If the code approach was followed and the unusual 1906 detailing was rejected as non-compliant these beams would all require strengthening. However, upon testing to ultimate loads no significant cracking was observed in 15 load tests and the secondary beams were accepted as capable of carrying ultimate design loads.

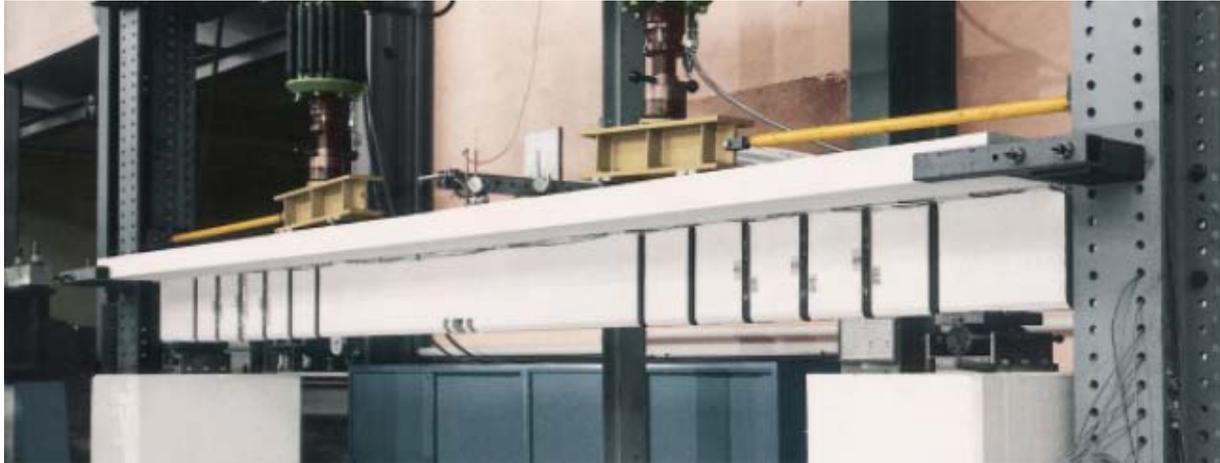
Figure 9 – Laboratory Testing of FRP Shear Strengthening

Shear strengthening comprised L-shaped strips of FRP laminate material that is inserted into slots cut through the deck slab and anchored with strong epoxy adhesive into the top of the beam section. Pairs of L-shaped strips are fixed one over the other to provide discrete U-bars at regular spacings which enhance the shear capacity of the reinforced concrete beam. This type of shear reinforcement has been tested on T-beams in laboratories in Switzerland to verify the equations used in design for additional shear strength.

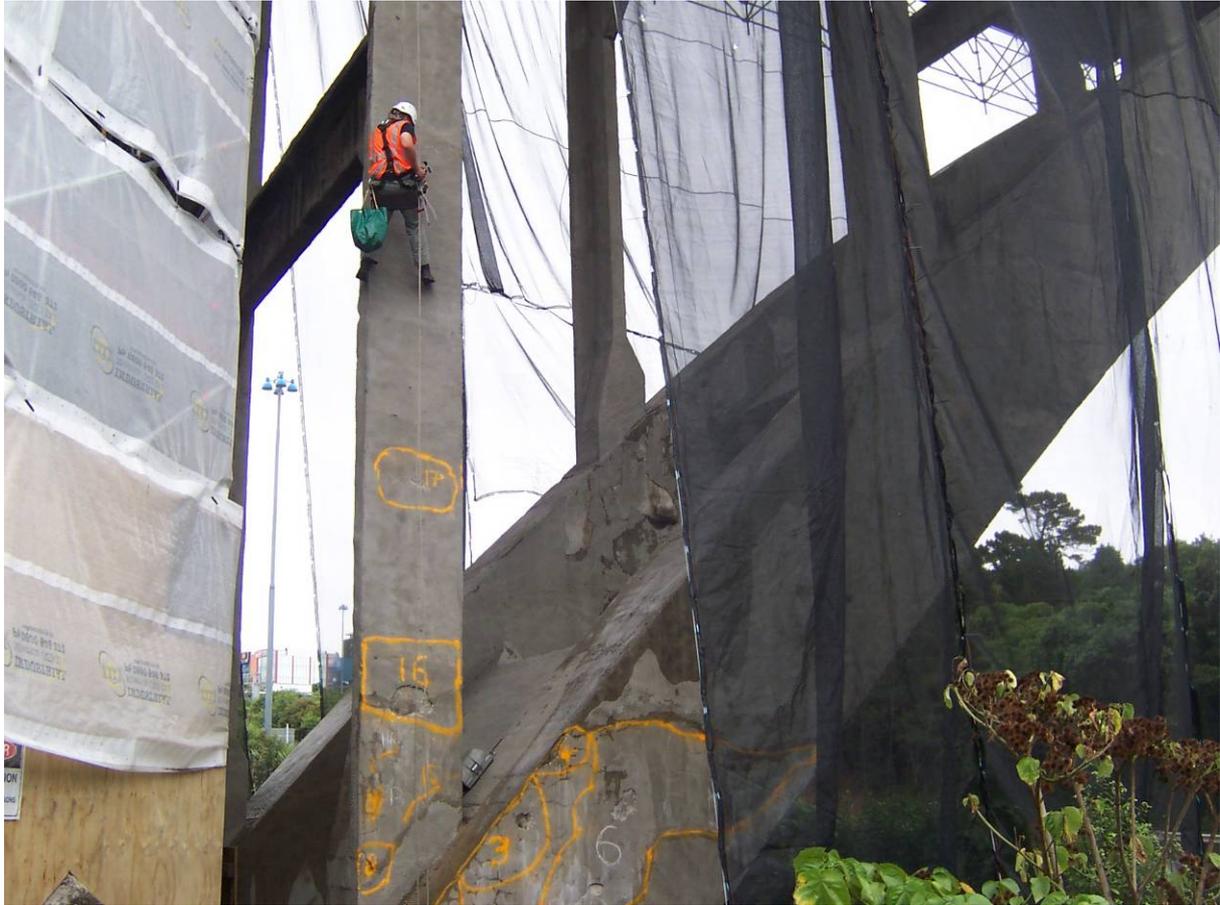
Figure 11 – High Level Inspection by Rope Access

For the first time in decades a detailed inspection of the entire bridge structure has been carried out. This involved some innovative access methods such as abseiling for high level areas, large mobile cherry pickers for motorway spans during night-time lane closures, and working off suspended scaffolds where extensive strengthening works are to be carried out.
